Housing Development – Kinnegad Co. Westmeath Stage 1/2 Road Safety Audit

Client:	JH KINNIE LTD.
Document No:	241139-ORS-XX-XX-RP-TR-13g-001 - RSA

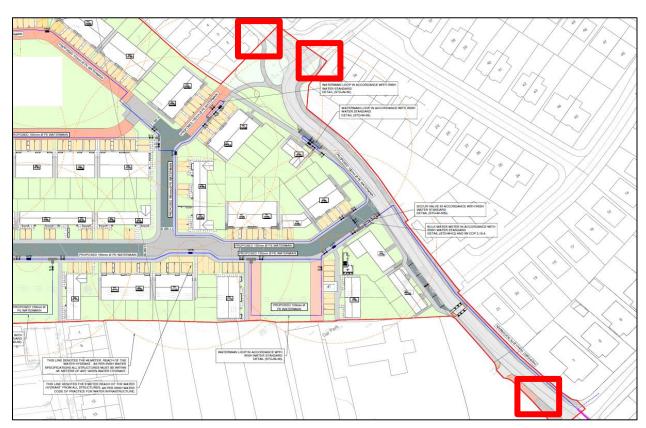
Problem No.01: Tie-in to Existing Footpath

The audit team note from the site visit and drawings and the site visit that proposed footpath ties into the existing footpath at the location identified. The drawings lack specific details regarding how these areas will interact and whether any enhancements will be made to the existing tie-in points. This absence of clarity raises concerns regarding the seamless transition between these areas. The audit team is concerned that any inadequate tie-ins and potential unevenness between these sections could pose a risk of trips and falls for site users, potentially leading to injuries

The design team should ensure the provision of clear and accessible tie-ins, along with any necessary improvements to the existing footpath to create a smooth and hazard-free transition between these areas.

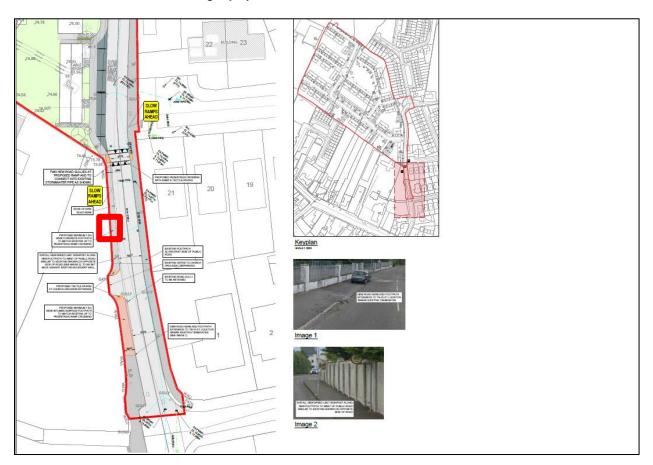
Problem No.02: Signage Useable Space of Footpath

The audit team note from the drawings provided, that it is intended to locate a new speed limit sign within the useable width of the footpath. Signage that are within the usable width of the footpath could lead to sudden manoeuvres of pedestrians onto the carriageway leading to collisions with vehicles causing injury.

The design team should ensure that any proposed signage does not reduce the useable width of the footpath.

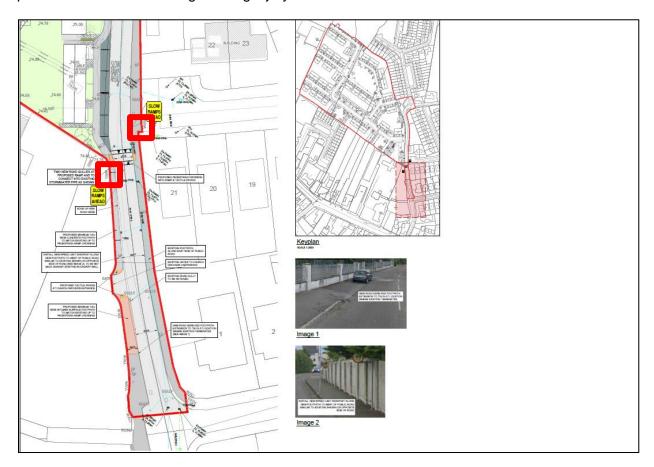
Problem No.03: Proximity of Ramp Warning Signage Location: Location Identified

The audit team note that the proposed advanced warning for 'Ramp Ahead' is positioned close to the ramp. The audit team is concerned that this will not give motorists adequate advance warning of the impeding hazard ahead and could result in an increased risk of collisions with pedestrians on the crossing causing injury.

The design team should provide the appropriate ramp sign with supplementary pedestrian warning signage the requisite distance from the hazard.

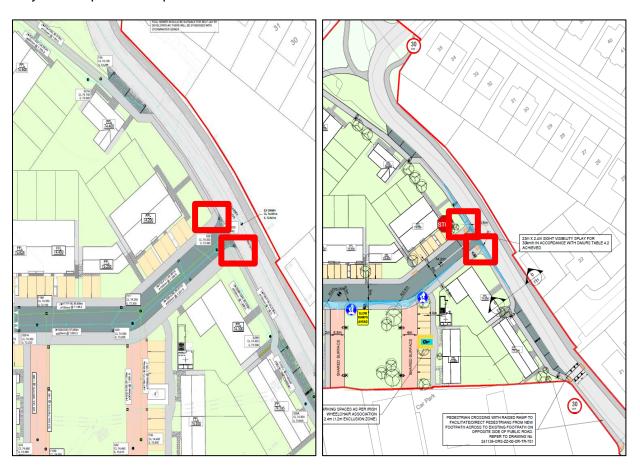
Problem No.04: Inappropriately Located Gullies

The audit team note from the drawings provided, that there are gullies located within areas designated for vulnerable road users at the locations identified. Inappropriate gully positioning may lead to potential trip and fall hazards for vulnerable users.

The design team should ensure drainage gullies are strategically positioned outside of pedestrian zones to mitigate the safety hazard identified.

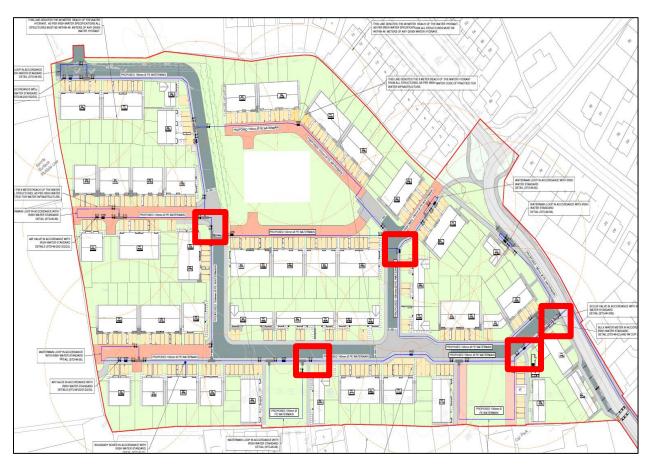
Problem No.05: Utility Manhole Locations

The audit team note from the provided drawings that utility manholes are proposed within areas designated for pedestrian crossings. It is not clear from the drawings provided if the utility manholes at the location identified are within the tactile paving. If crossings are not kept clear of manhole covers and are not level with the pavement surface or should the surface be slippery, it may pose challenges for vulnerable road users, potentially resulting in trips and falls.

The design team should ensure that manholes are positioned outside of the crossing zone and finished level with the surface.

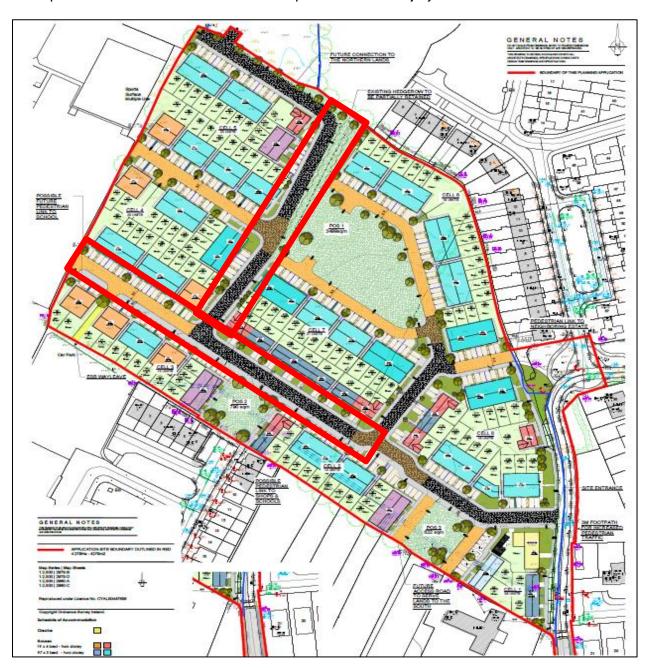
Problem No.06 Speed Control Measures and Road Widths Location: Main Access Road

The audit team note from the drawings provided, that there are no speed control measures proposed throughout the scheme. The audit team are concerned that the layout as its currently presented particularly with the excessive road widths could encourage higher speeds which could put vulnerable users within the development at risk of injury in a collision.

The design team should ensure that appropriate speed control measures are incorporated within the development to reduced vehicular speeds. The design team should also ensure that the road width is reduced to mitigate the risk of speeding further.

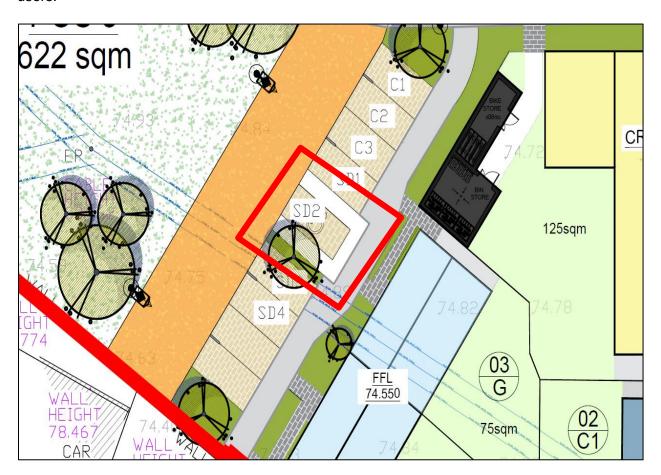
Problem No.07: Dropped Kerbs Provisions for Mobility Impaired Users Location: Accessible Parking Space

The audit team note from the drawings provided, that there is disabled parking spaces provided within development. It is not clear from the drawings provided if appropriate dropped kerbing is provided for these spaces at the locations identified below. The audit team are concerned that users of the spaces may not have access to the footpath and may use the closest road to access the footpath resulting in potential collisions between vehicles and vulnerable road users.

The design team should provide adequate provision for users of the spaces to access the footpath safely.

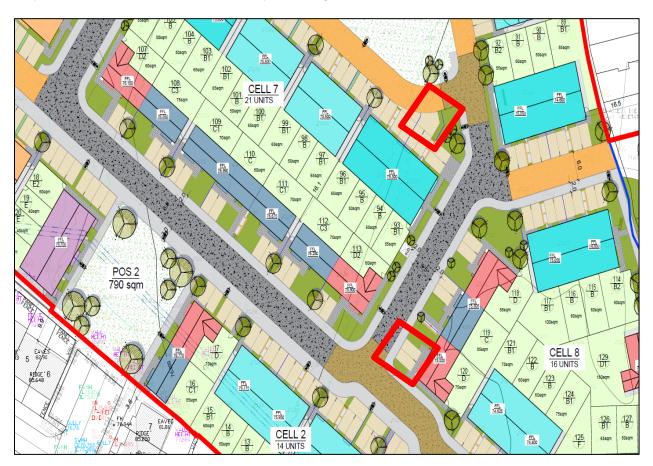
Problem No.08: Vehicular Entrances

The audit team note from the drawing's provided that the vehicular entrance to the properties identified are on the inside radius of the turn and may not be adequately sighted when travelling along the main access road. The audit team would have concern's that vehicles exiting the site would not have full visibility of oncoming traffic and likewise oncoming traffic may not have sufficient forward visibility resulting in vehicular collisions.

The design team should ensure that the boundary treatments do not impeded visibility from the parking spaces or forward visibility

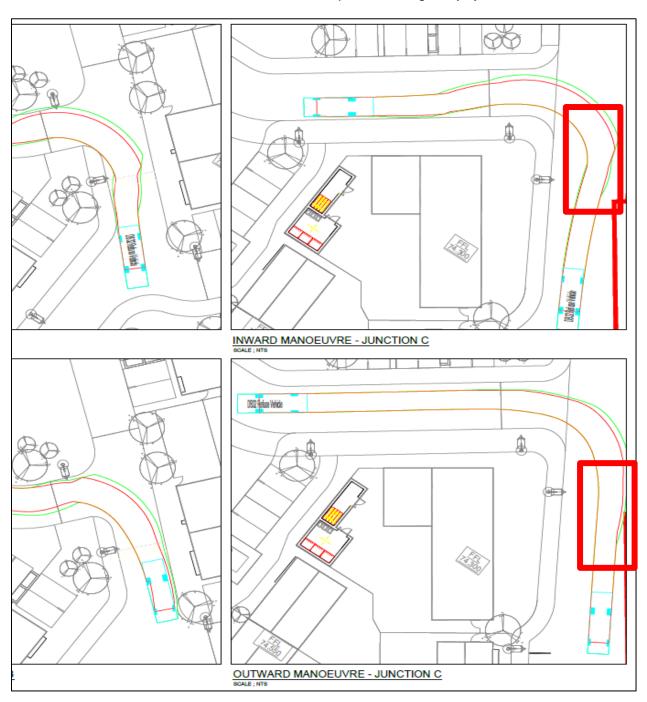
Problem No.09: Vehicle Swept Path Analysis

The audit team noted from the drawings provided that the refuse truck entering and exiting the development may have to mount the footpath at the locations identified to enter and exit the development. The audit team concern is that refusing trucks mounting the footpath will come into collision with vulnerable road users on the footpath resulting in injury.

The design team should provide a swept path analysis which does not infringe on pedestrian infrastructure.

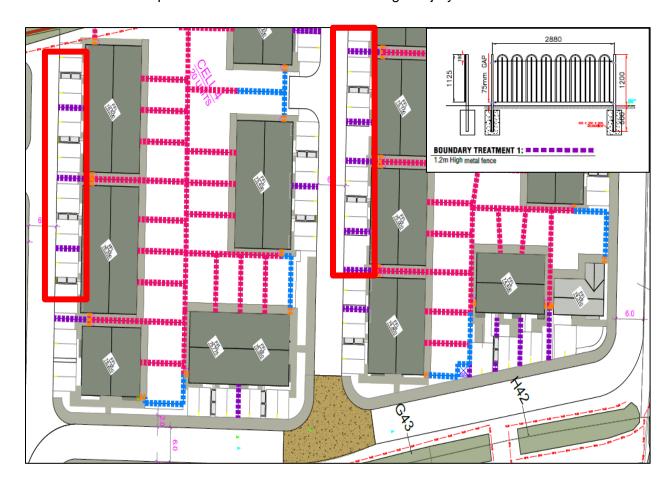
Problem No.10: Boundary Treatments Location: Throughout Development

The audit team note from the drawings provided that proposed boundary treatment to the private parking spaces within the development may impact the visibility of road users if positioned inappropriately. The boundary treatment should be appropriate where visibility is to be maintained to ensure that drivers are clearly able to see approaching vehicles and pedestrians at junctions and designated pedestrian crossing locations. This could potentially lead to instances of vehicle-vehicle or pedestrian-vehicle collisions resulting in injury.

The design team should ensure that any proposed boundary treatment does not impact on visibility of the internal roads and junctions or forward visibility.
